LaSalle County Station, Unit 1
Facility Operating License Nos. NPF-11
NRC Docket No. 50-373

Subject: Licensee Event Report

LICENSEE EVENT REPORT (LER)

Crane Model 973A Tilting Disc Check Valve

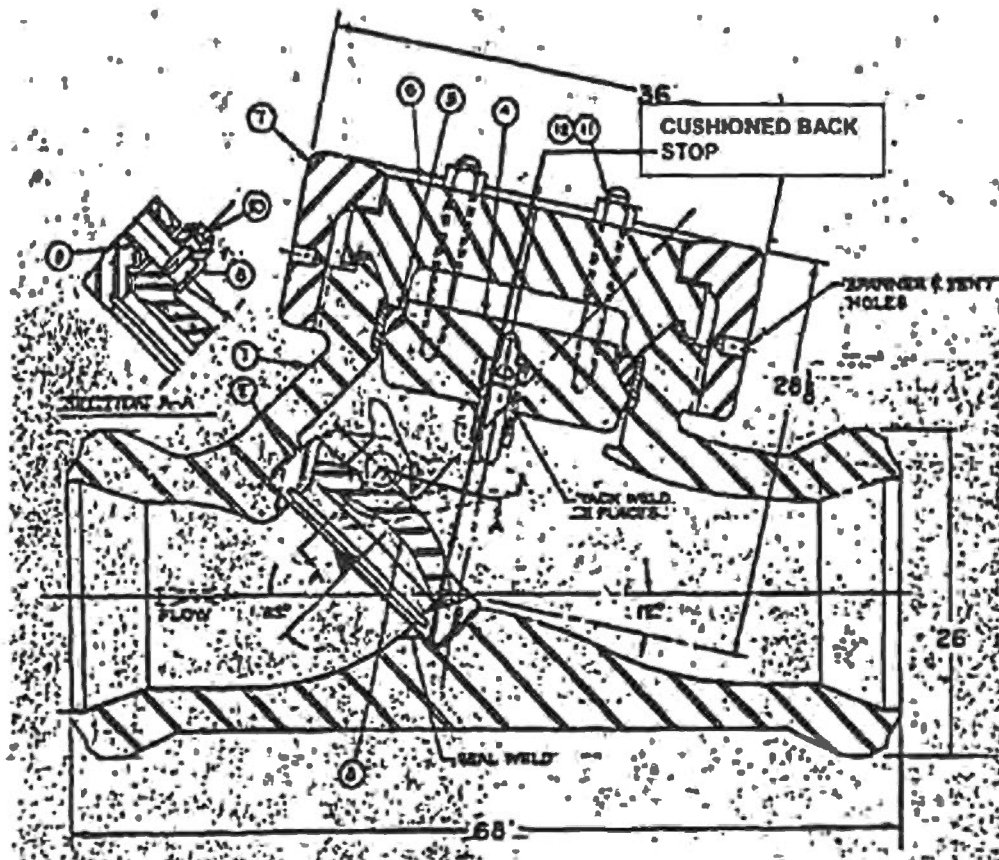
Figure 1

The root cause of the failure was inadequate design. The cross-section of the integral over travel disc stop contact surface, due either to original casting or excessive final grinding during manufacture, was reduced to the point that the disc stop would strike on the angled surface of the seat ring rather than the flat area. This imparted a lateral force to the disc that resulted in binding between the disc hinge ears and the seat ring hinge ears (See Figure 1).

1. TDRFP discharge check valve 1FW001A was inspected, and new hinge pins and a cushioned back stop were installed prior to the restart of Unit 1 on 11/28/03. This action is complete.
2. The integral over travel disc stops for the TDRFP and MDRFP discharge check valves on both Units (1/2FW001A/B and 1/2FW002) and the Condensate Booster Motor Driven Reactor Feed Pump supply bypass discharge check valves on both Units (1/2FW023) will be inspected for proper contact with the seat ring. Where necessary, the assembly will be replaced, or the contact surface area of the disc stop will be increased using weld build-up in accordance with vendor recommendations (AT#188345-29 to 34).
3. The design of the cushioned back stop for the affected valves will be revised to incorporate vendor configuration enhancements and to revise the weld configuration and size (AT# 188345-35, 36).

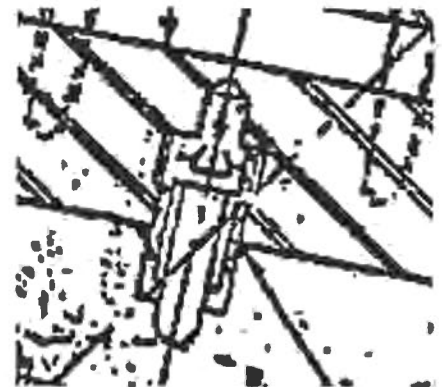
Cushioned Back Stop

A contributing factor was that the check valve cushioned back stop was missing. The cushioned back stop is designed to give the disc a push closed on vertical installations of the check valve. Although the check valves at LaSalle are installed horizontally, the cushioned back stop could have stopped the disc when swinging open without the disc stop impinging the seat ring. The apparent cause of the missing cushioned back stop was a failure of the tack welds that held it in place.
